Description of standing remains at Bedlington Ironworks.

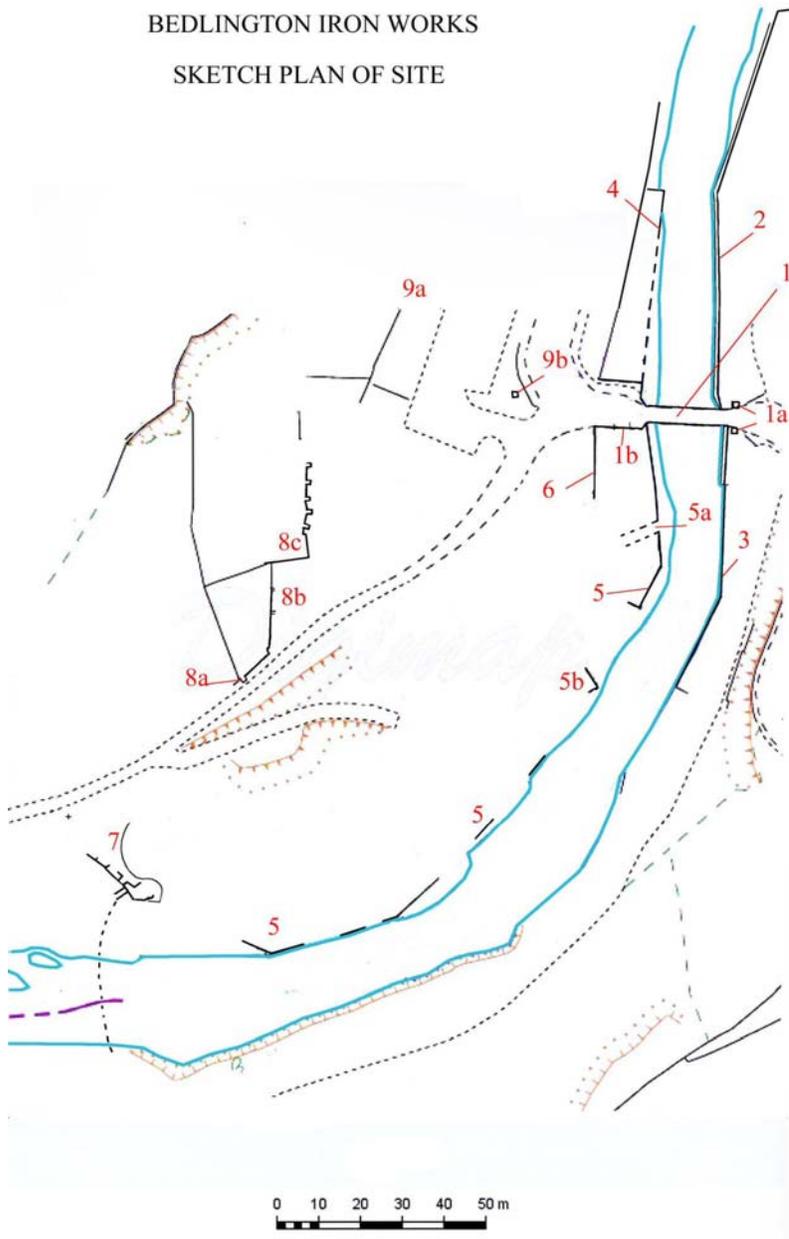
Historic maps and illustrations show an extensive series of buildings and other structures, many of them associated with the Bedlington Iron Works, centred on Furnace Bridge. Apart from the bridge and some retaining walls on each bank of the river, relatively little survives above-ground today. At the bridge the river is flowing north-south; to the south it swings south-west, so that at the dam it is flowing east-west. In the following description upriver is always termed south and downriver north. The description is keyed to a sketch plan of the site which uses historic and modern maps and was prepared following a site visit on March 2nd 2009.
